GEOTECHNICAL EVALUATION  
PROPOSED CANYON VILLAS AT THE WELK RESORT  
TM 5313/REZ 03-004/S03-029/ER79-08-099A/ZAP08-010  
ER 79-08-099A/SCH #2003071108  
WELK VIEW DRIVE  
ESCONDIDO, CALIFORNIA

CTE JOB NOS. 10-6305 & 10-6349

REVISED DATE APRIL 30, 2009

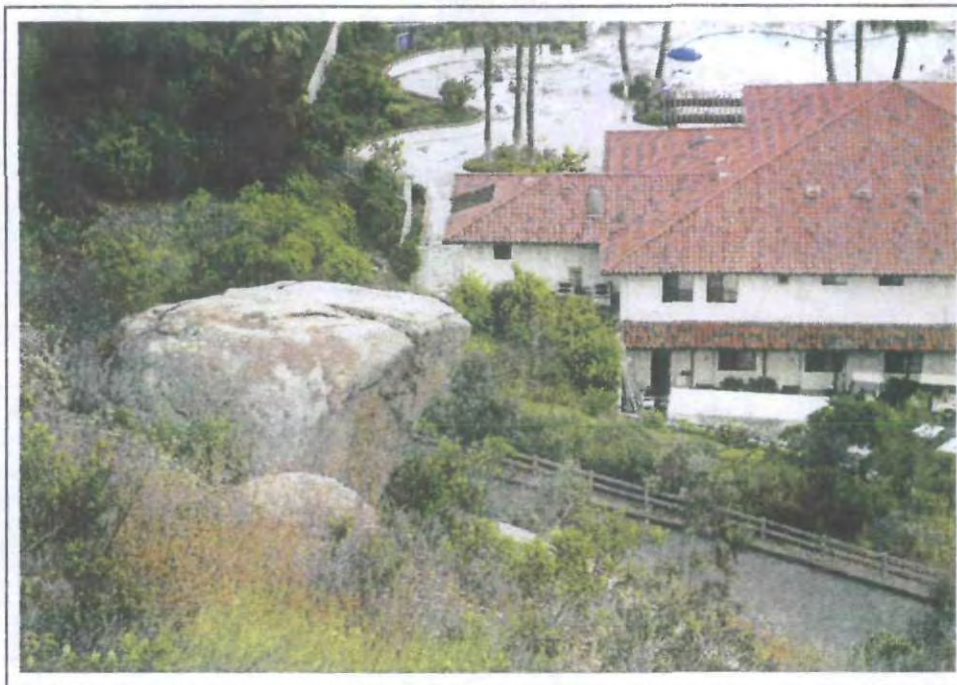
Photo #1: Typical boulder shape above Welk Drive area.

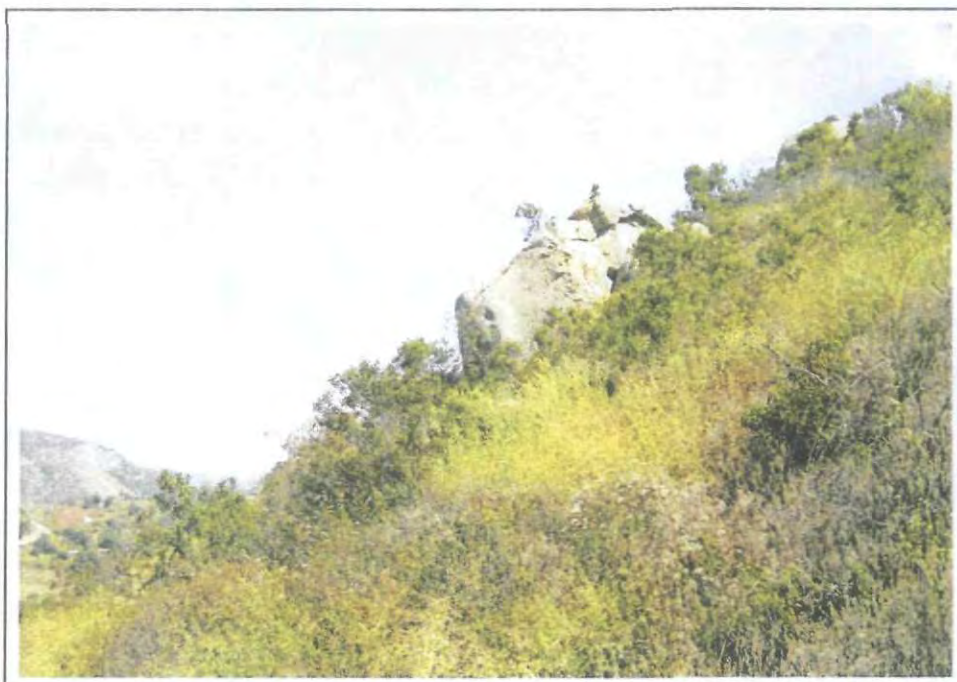
Photo #2: Typical boulder shape above proposed Canyon Villas site.

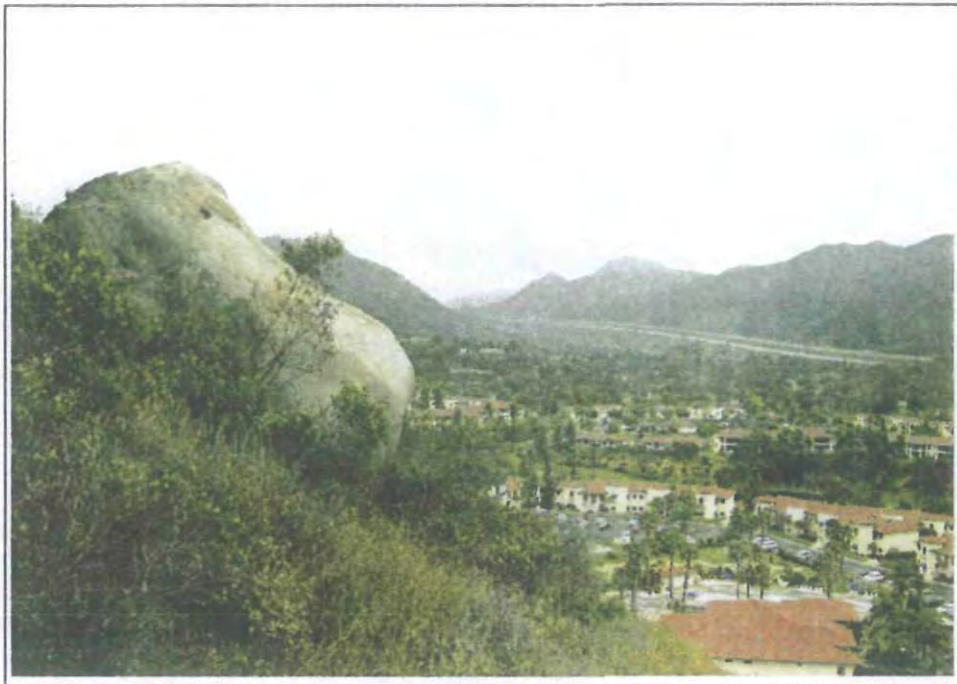
Photo #3: Typical boulder shape above proposed Canyon Villas site. Existing Villas on the Green development is in the background.

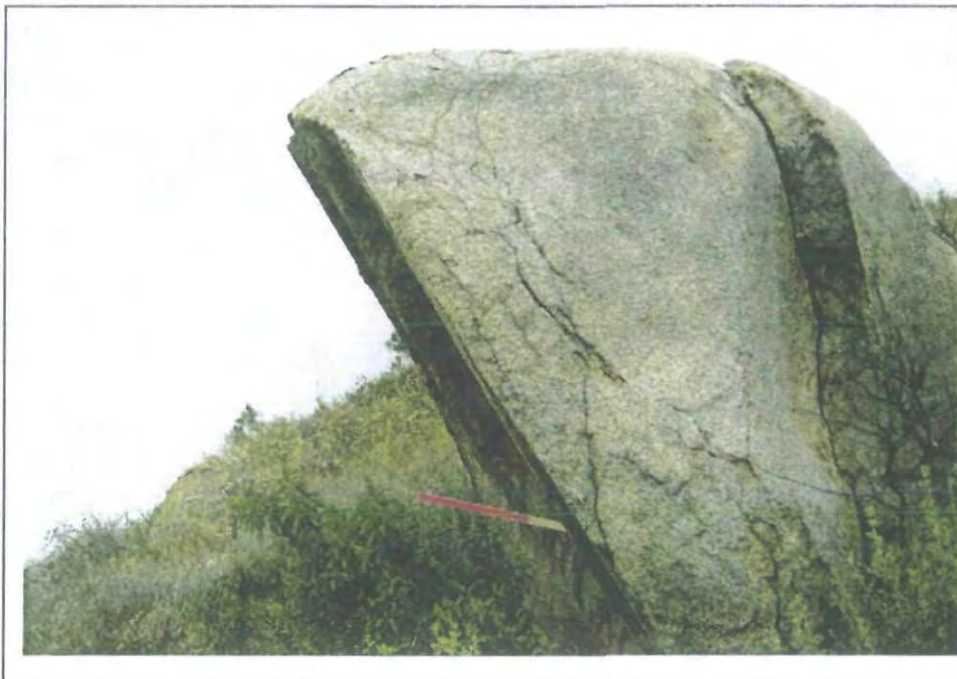
Photo #4: Fractured boulder LOT 5. Survey stake is approximately three feet long.

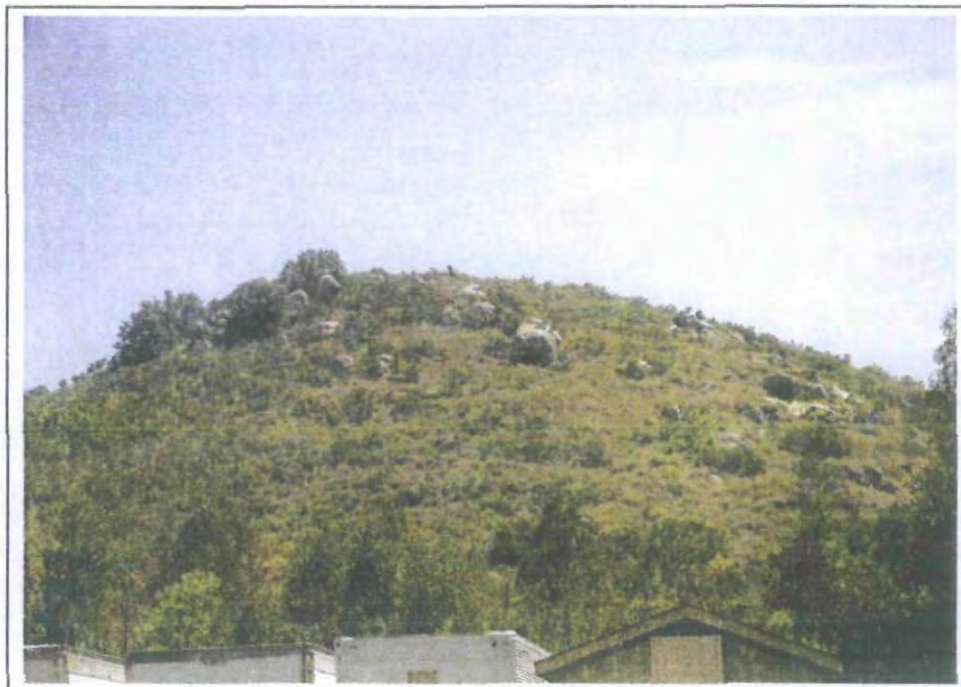
Photo #5: Slope above proposed Canyon Villa site.

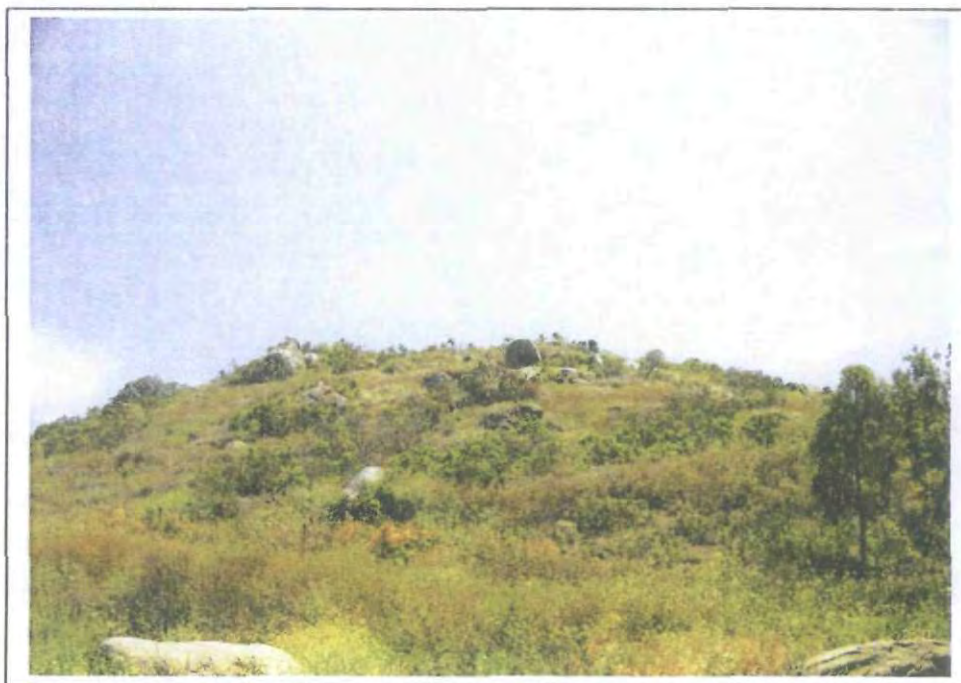
Photo #6: Typical boulders shapes above proposed Canyon Villas site, Lot 5 area.
